Automation in Transportation Accidents

Deborah Bruce
National Transportation Safety Board
Washington, DC

Automation Accidents

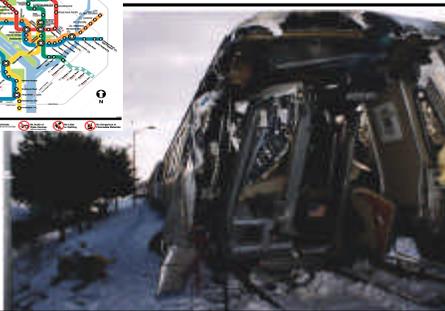
Metro train

- Controllers instructed the train to continue Automatic mode, set speed at lower performance level (59 mph).
- Train overruns Twinbrook Station (told by controllers not to service station go to next in Automatic mode).
- The train then overran Rockville Station by one car. Results in *performance level* loss because the train was not within platform limits.
- Thus, the train departed to Shady Grove Station at 75 mph (rather than 59 mph). Train overran station by 470 ft, struck and telescoped 21 feet into standing train.

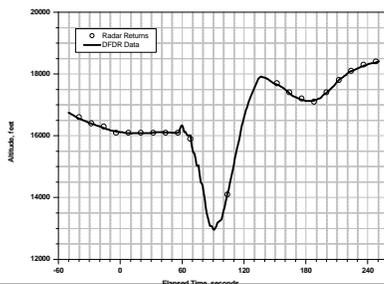
AA 903 Altitude Plot

- Autothrottle set to hold 210 knots
- Engaged at start of descent from FL240
 - During descent - power reduced from idle to mechanical stops
- Not engaged at level off at FL160
- Airspeed decreased
- About 170 knots flightcrew advanced throttles
- Stall warning activated and upset occurred
- No evidence of autothrottle malfunction
